B O N N E V I L L E
P O W E R A D M I N I S T R A T I O N

Level I Accident Investigation Report

Wilson Construction Company Employee Fatality on the Bandon-Rogue No. 1 115kV Line

**Report Date:
September 2013**

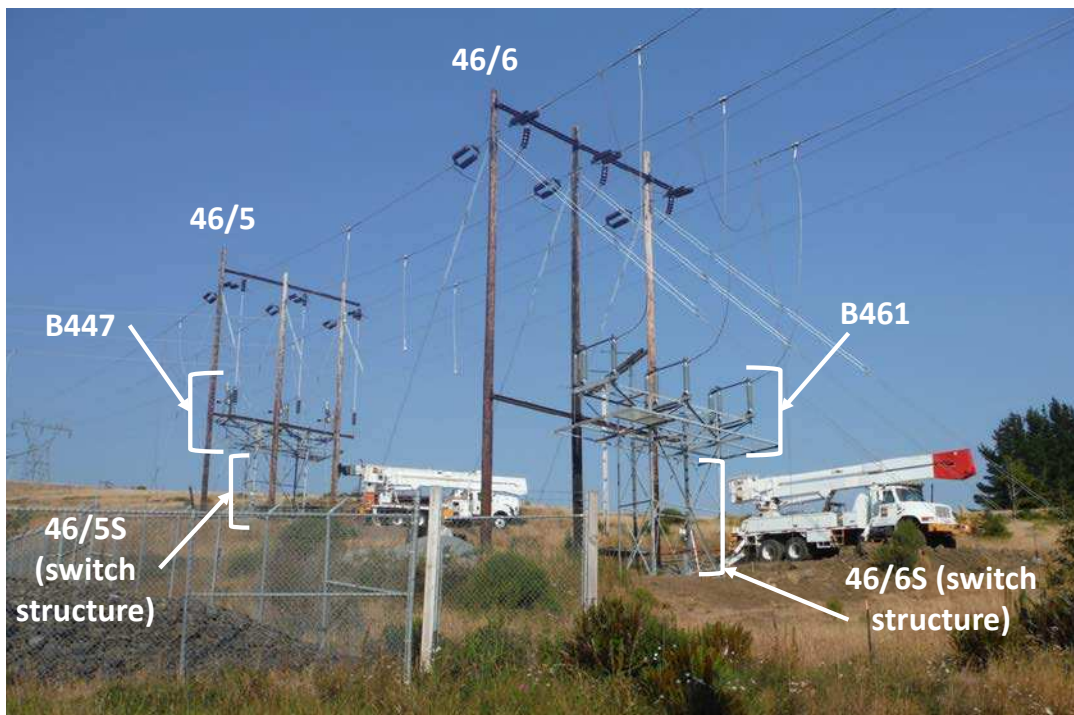
Figure 1: Geisel Monument Worksite

The specific work required at structure 46/5 and 46/6 included relocating switch stands 46/5S and 46/6S (Figure 1), two additional feet away from their respective transmission structures and two additional feet away from the Geisel Monument Substation fence.

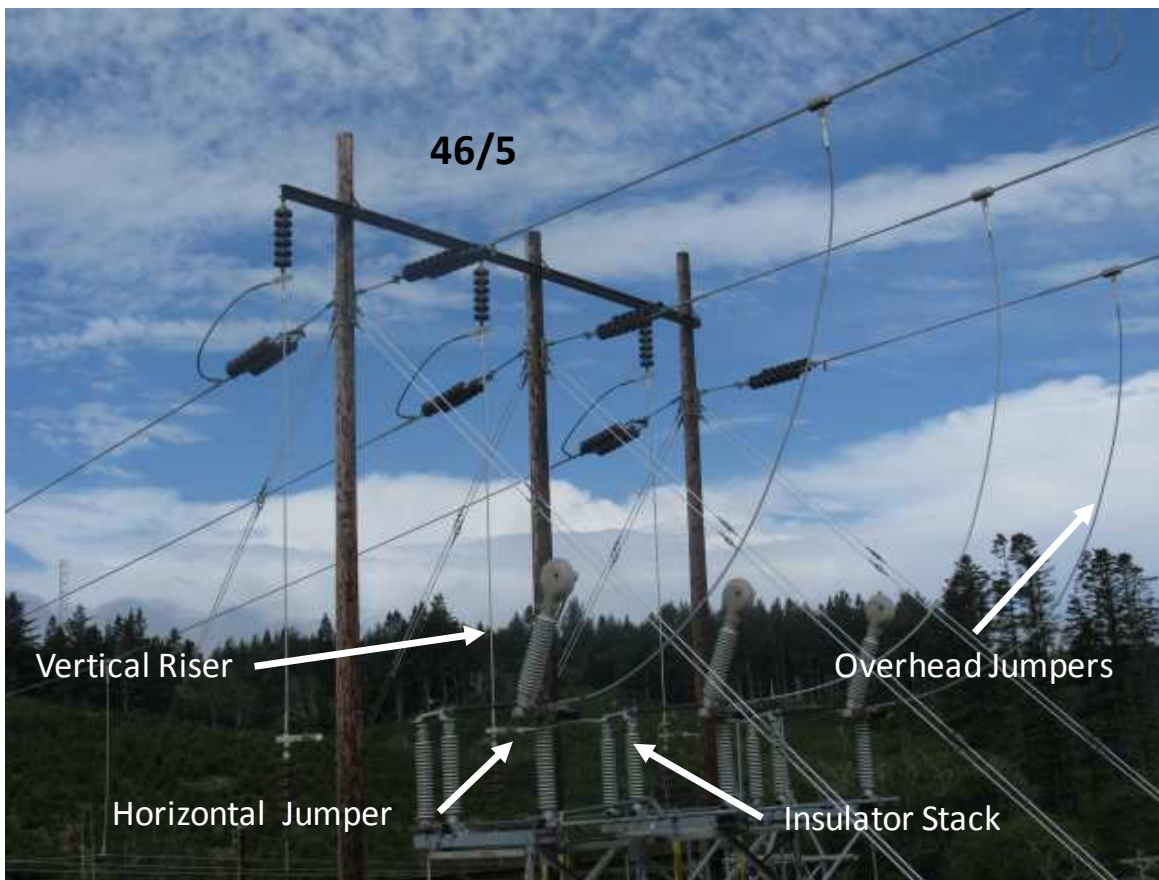
Figure 2: Riser and Jumper Location on Structure 46/5

In addition, new vertical risers were to be installed from the bottom cross arm to the upper cross arm on each structure and the horizontal jumpers from the bottom cross arm to the switch were to be replaced with a higher capacity conductor (Figure 2). Jumpers from the overhead line to the harp end of the switch were to remain in place as constructed in the original release.

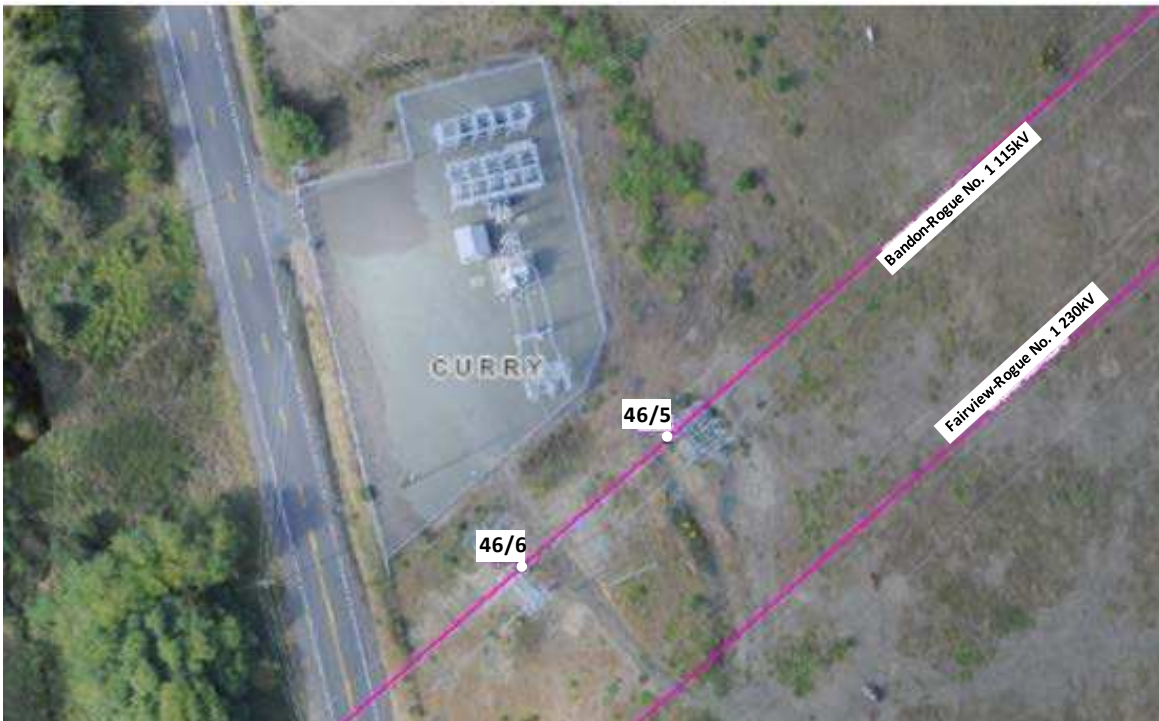
Figure 3: Aerial View of the 46/5 and 46/6 Structures at the Geisel Monument Tap

Upon arrival at the Geisel worksite at approximately 0800, the crews conducted the job briefing of the specific work hazards and how the work was to be performed. The plan of the day was for the six men to break into two crews for work on their respective switch at 46/5 and 46/6. Crew 1 was at structure 46/6 and Crew 2 at structure 46/5. (Figure 3)

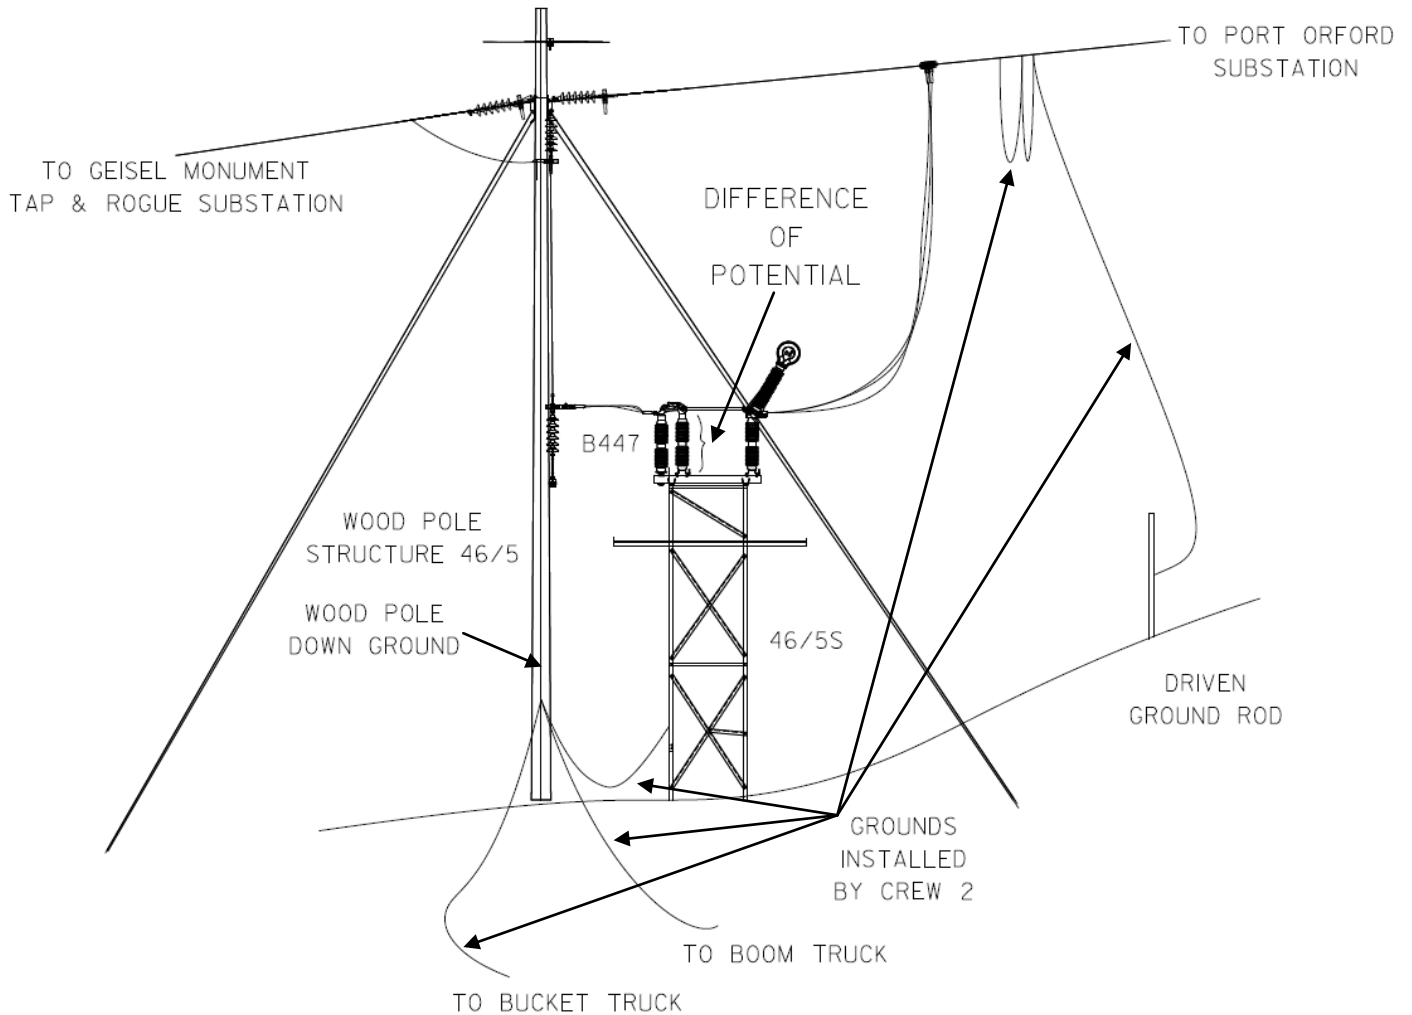
Figure 4: Grounds Installed by Crew 2 at Worksite 46/5

A three phase ground set was installed on the overhead line above the worksite at 46/5 by Crew 2. There was no step and touch voltage measurement taken at the 46/5 ground rod. No EPZ was established by Crew 2 at 46/5 because they did not bond the driven ground rod to 46/5S. (Figures 4 and 5) The tap into Geisel Monument was left ungrounded as neither crew installed a master set of grounds on the tap line.

FINDING 13: The Board found that Crew 2 did not install a ground between 46/5S and the driven ground rod thus failing to establish an EPZ between all the conductive parts at their worksite.

RECOMMENDATION 10: The Board recommends that WCC management ensure all workers follow the documented grounding procedures outlined in WCC's Safety Manual and the Site Specific Safety Plan (SSSP) posted on-site.

RECOMMENDATION 11: The Board recommends that WCC management establish and implement a formal training program on all grounding processes and procedures.

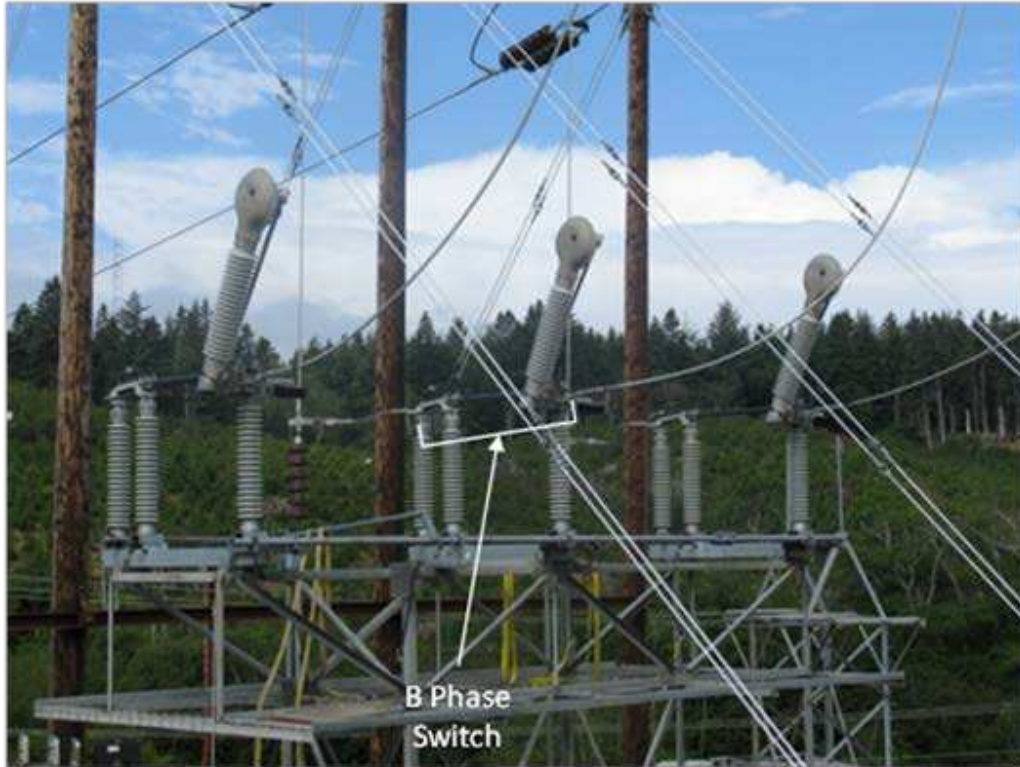
Figure 5: Structure 46/5S Switch B447

The Board concluded the **direct cause** of the accident was that CF2 made contact with a difference of potential across the blade end insulator stack of B447.

The Board concluded the **root cause** of the accident was Crew 2's failure to establish an equipotential zone (EPZ).

By about 0930 at structure 46/5, JL2 was in the bucket truck removing the sectionalizing jumper on A-Phase when CF2 climbed up to the top of the switch stand to attach lift slings suspended from the crane. Once the lift slings were placed and pulled up snug, CF2 positioned himself at the east side of the center switch to assist JL2 in the removal of the blade end sectionalizing jumper on B-Phase.

At approximately 0945, CF2 made contact with a difference of potential across the blade end insulator stack on B447.
