B O N N E V I L L E
P O W E R A D M I N I S T R A T I O N

Level I Accident Investigation Report

Wilson Construction Company Employee Fatality on the Bandon-Rogue No. 1 115kV Line

**Report Date:
September 2013**

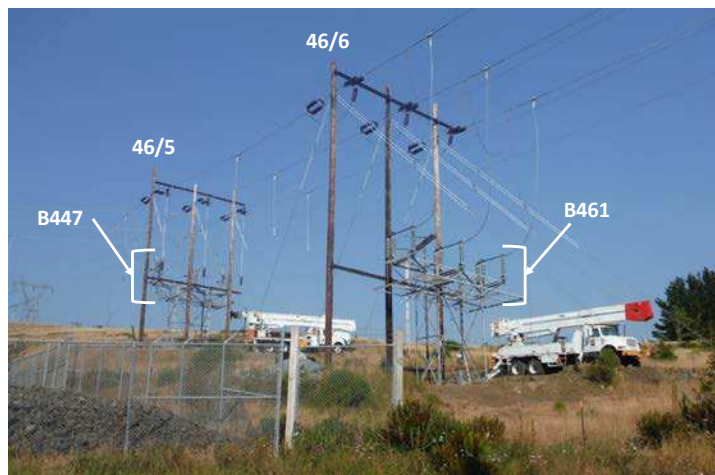
By about 0930, WCC Crew Foreman 2 (CF2) climbed up to the top of B447 switch stand to attach lift slings suspended from the crane. Once the lift slings were placed and pulled up snug, CF2 positioned himself to assist in the removal of the blade end sectionalizing jumper on B-phase.

At approximately 0945, CF2 made contact with a difference of potential across the blade end insulator stack of B447.

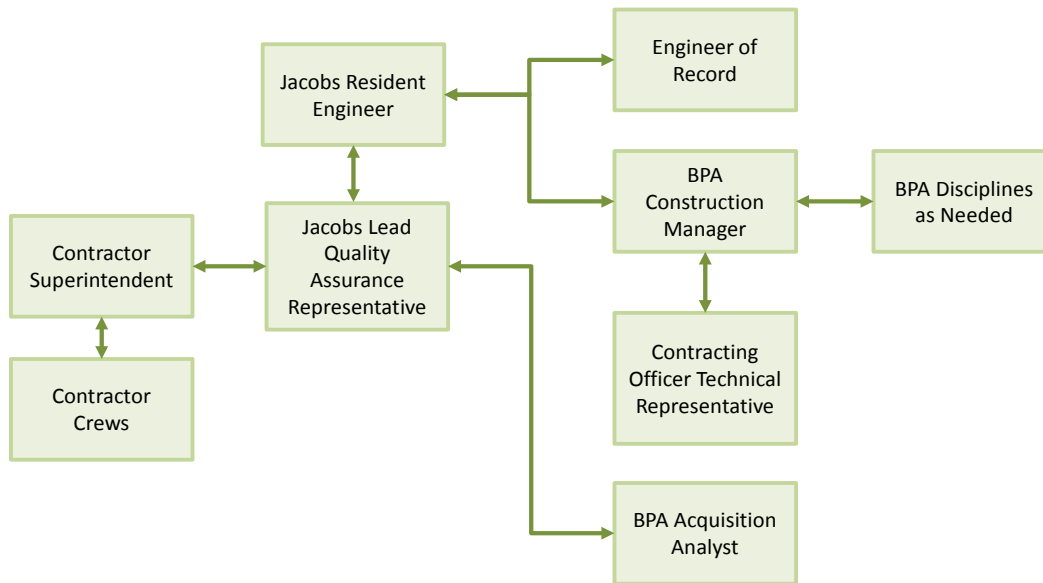
Figure 6: General Contractor Project Communication Diagram

The Superintendent is the first line for field questions on the project. If the answer to a question cannot be determined by the Superintendent, the question is passed on to the Quality Assurance Representative. Questions regarding field issues, safety, or material issues can often be resolved at this level.

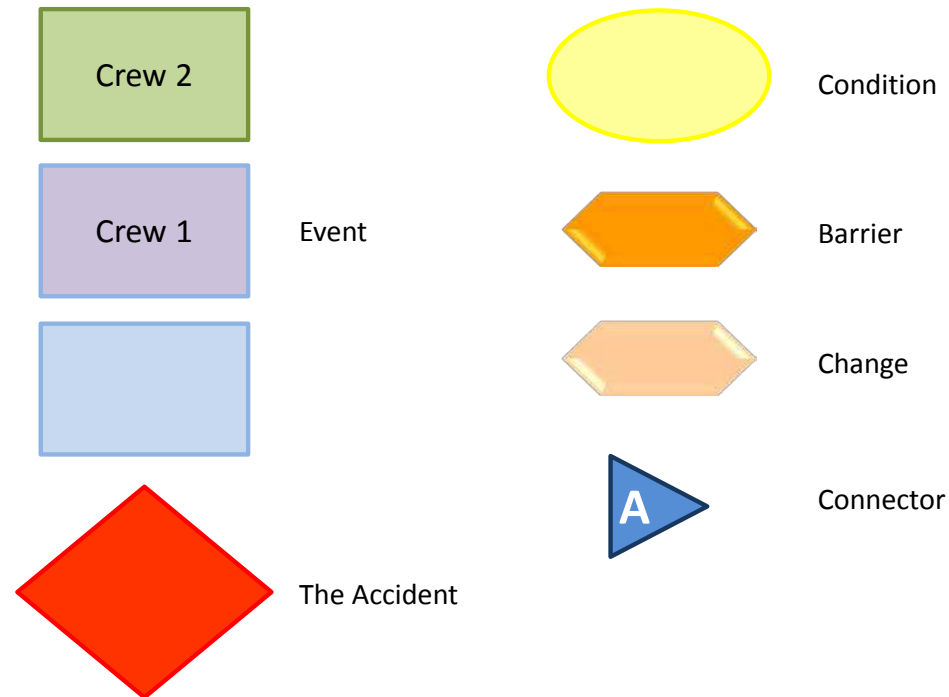
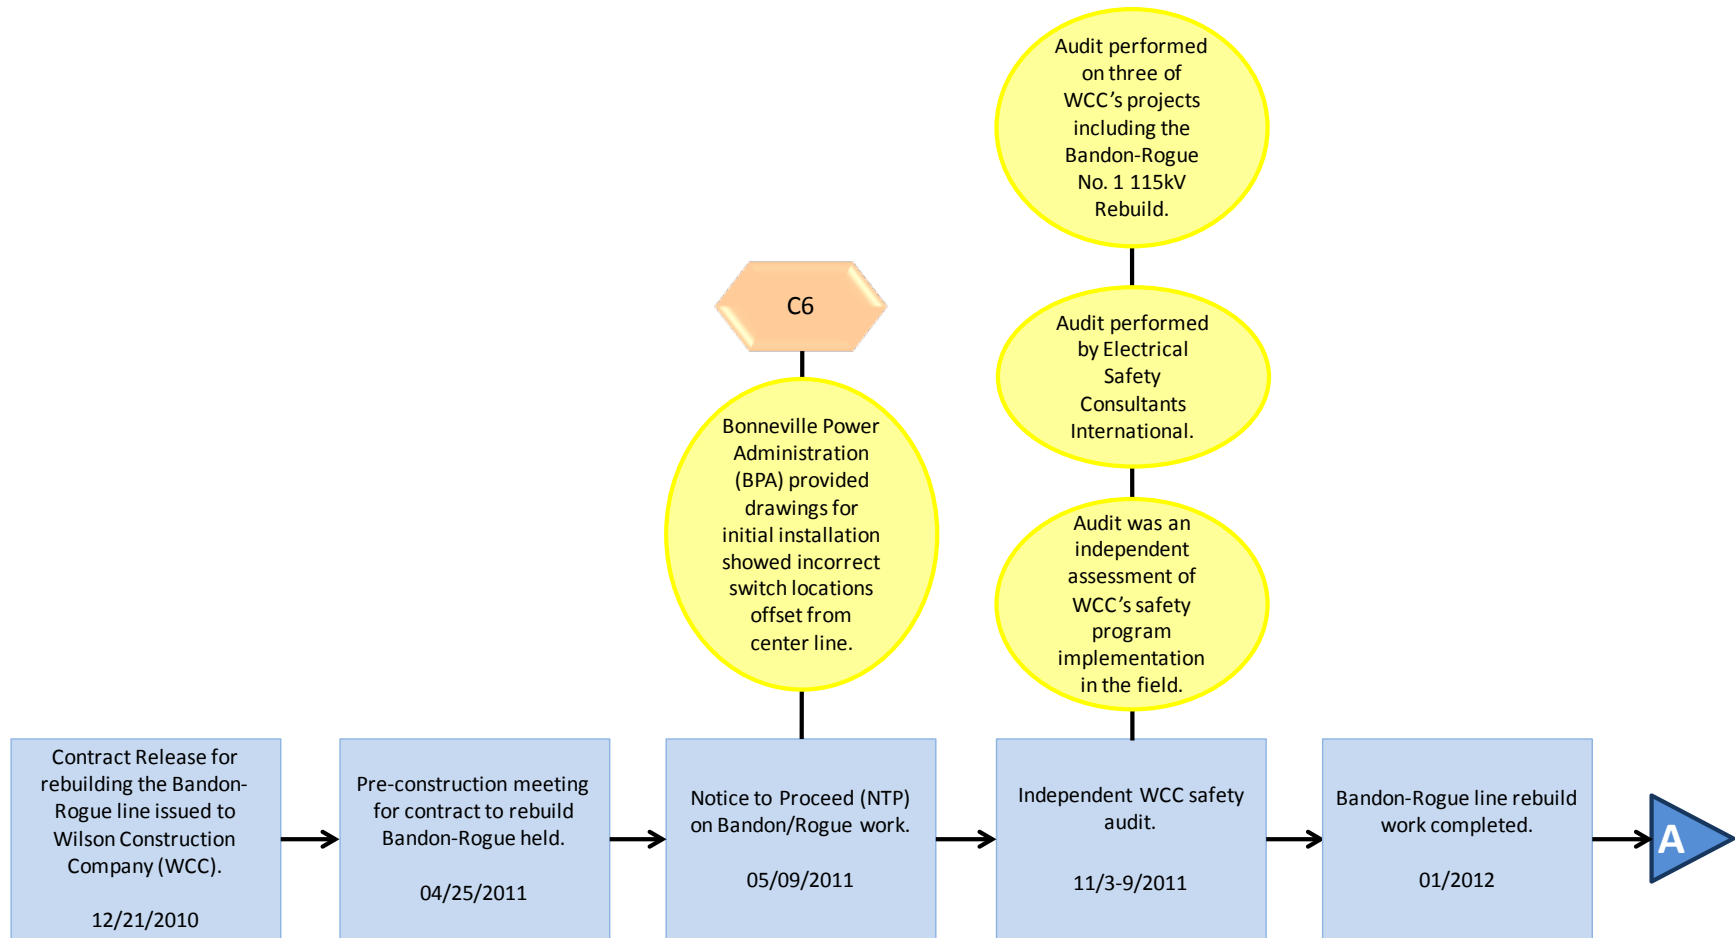
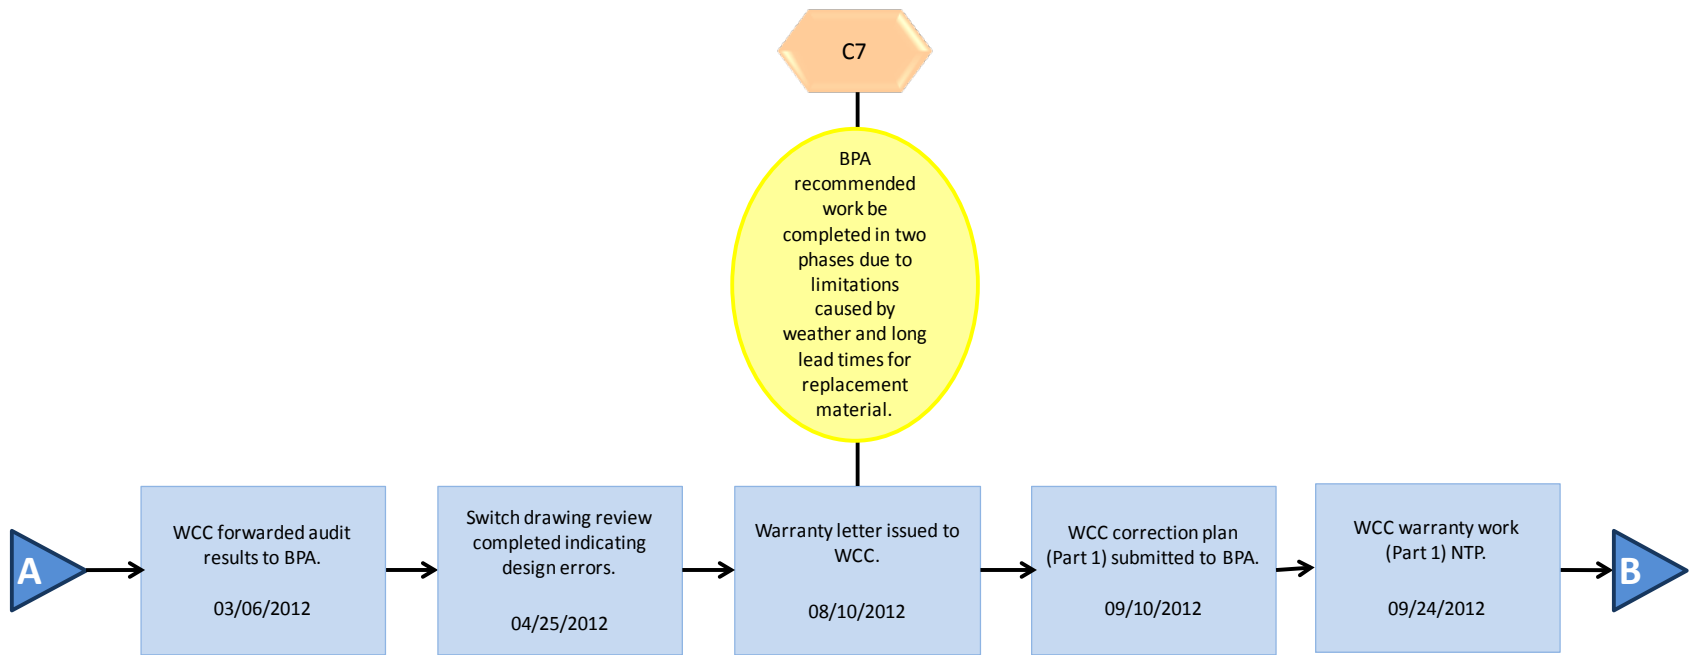
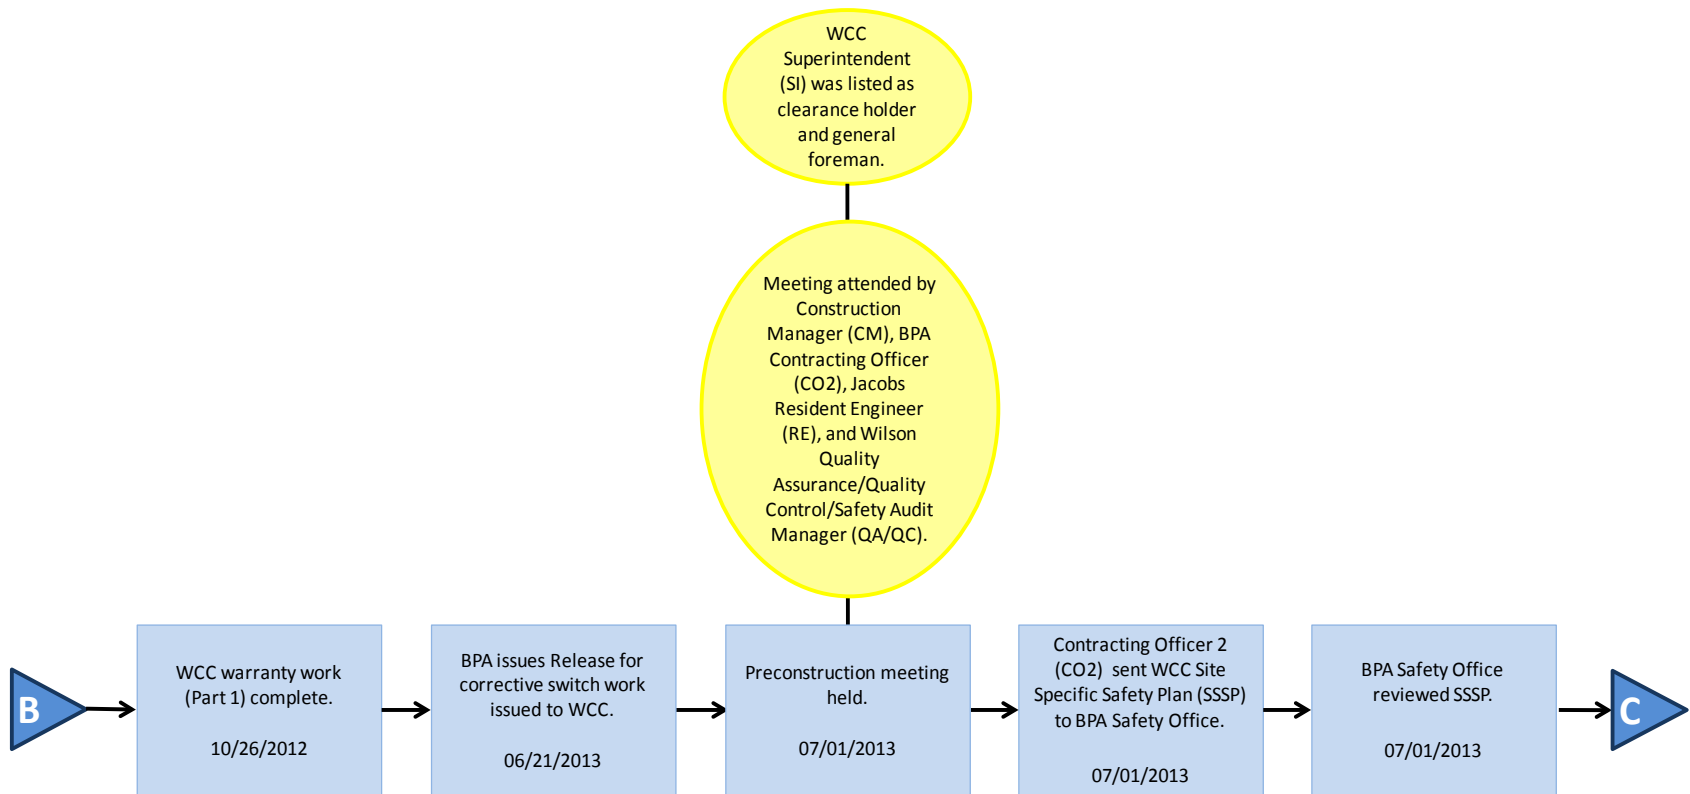
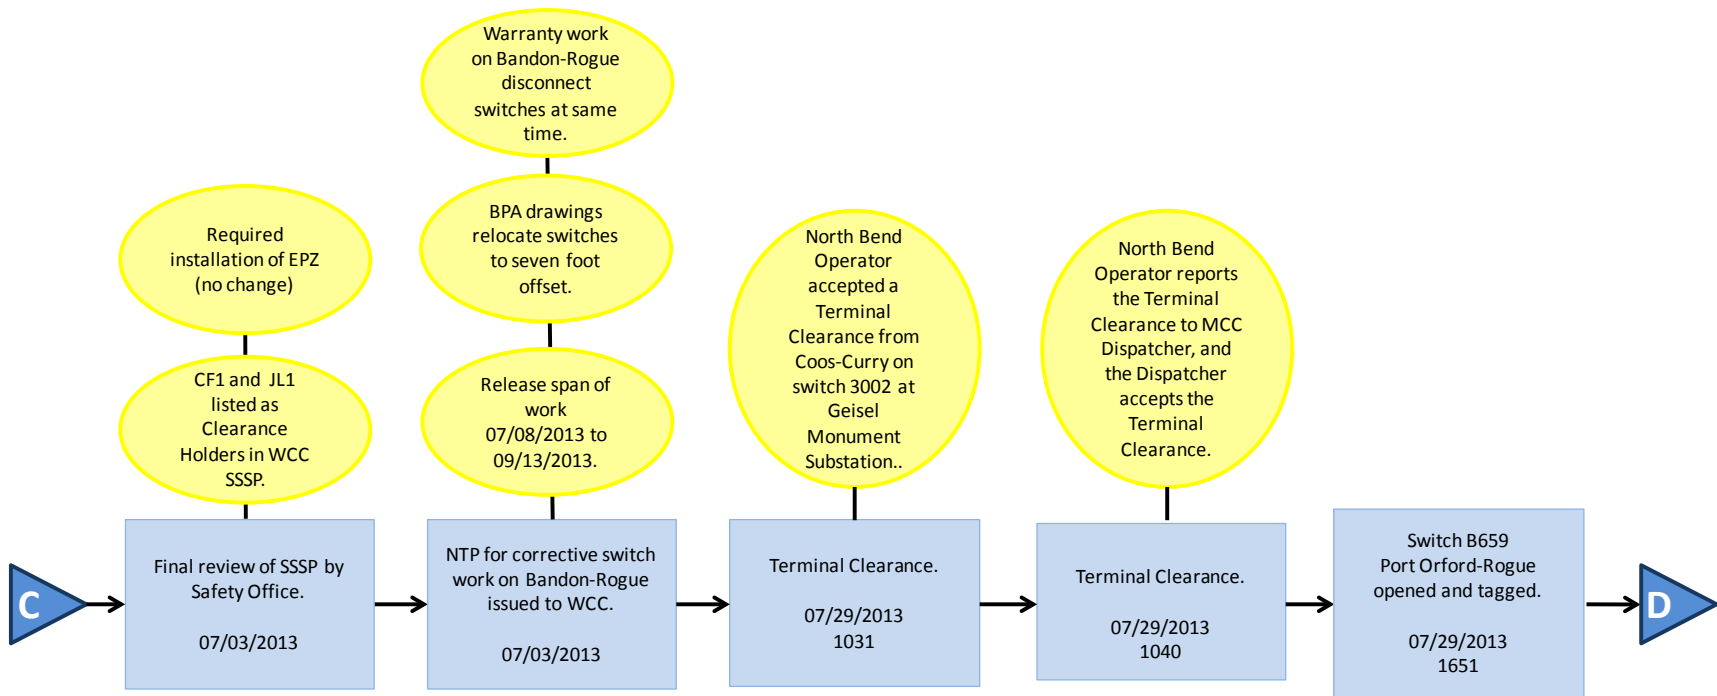
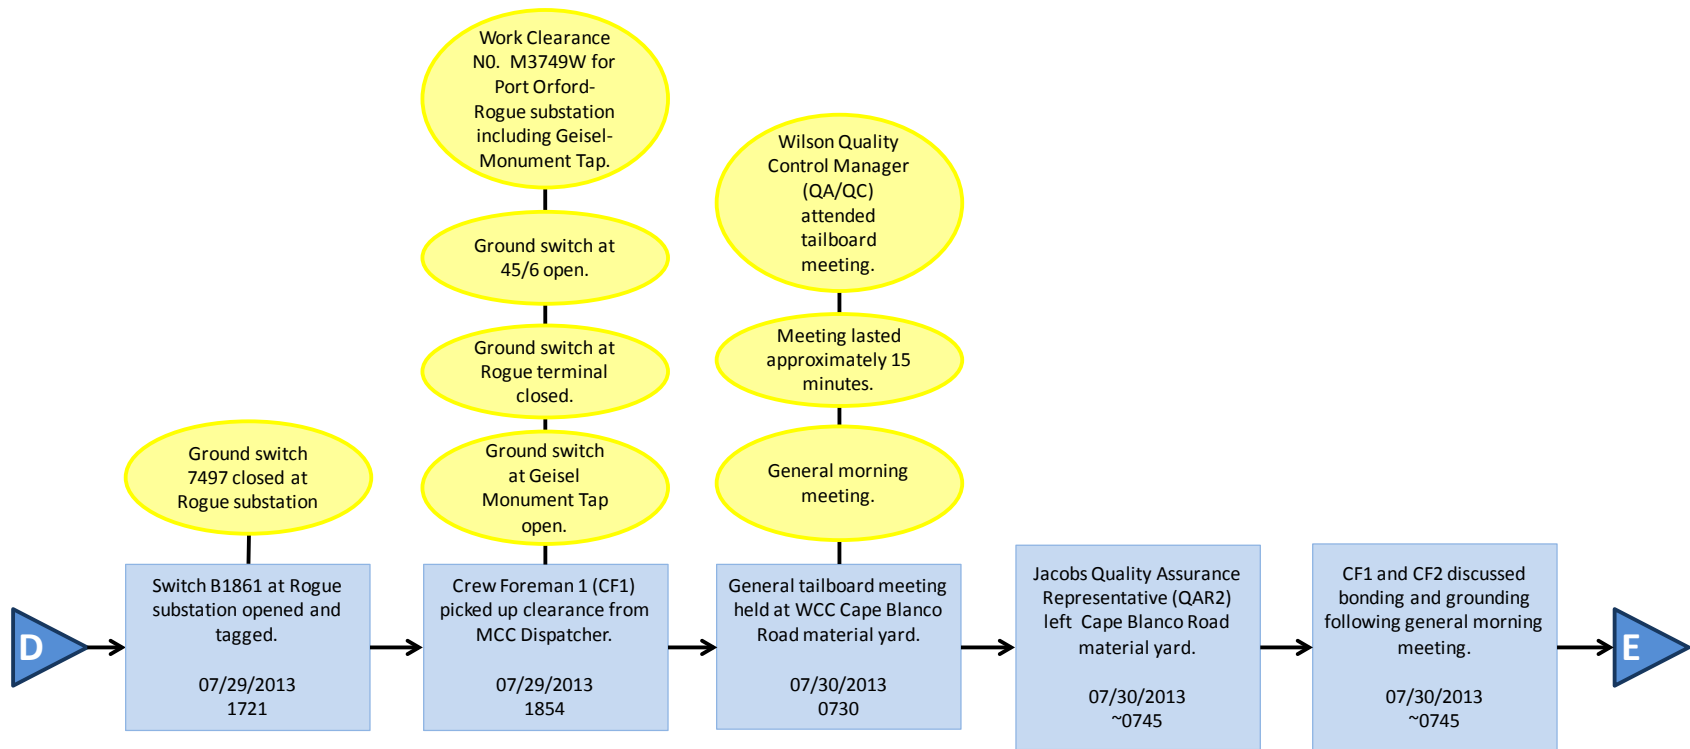
Table D-1: Events and Causal Factors Chart

An events and causal factors analysis was performed in accordance with the DOE workbook *Conducting Accident Investigations*. The events and causal factors analysis requires deductive reasoning to determine those events and/or conditions that contributed to the accident. Causal factors are the events or conditions that produced or contributed to the accident, and they consist of direct, contributing, and root causes. The direct cause is the immediate event(s) or condition(s) that caused the accident. The contributing causes are the events or conditions that, collectively with the other causes, increased the likelihood of the accident, but which did not solely cause the accident. Root causes are the events or conditions that, if corrected, would prevent recurrence of this and similar accidents. The causal factors are identified in Table D-1: Events and Causal Factors Analysis Chart.
